Scientific Evaluation Report "FluidTron" Nonchemical Device on Cooling Towers

Device Evaluated

"FluidTron Systems" electrostatic non-chemical device (NCD) manufactured by Electrostatic Equipment Company, Kansas City, MO, and marketed by several distributors, such as Dotson Sales in Phoenix, AZ.

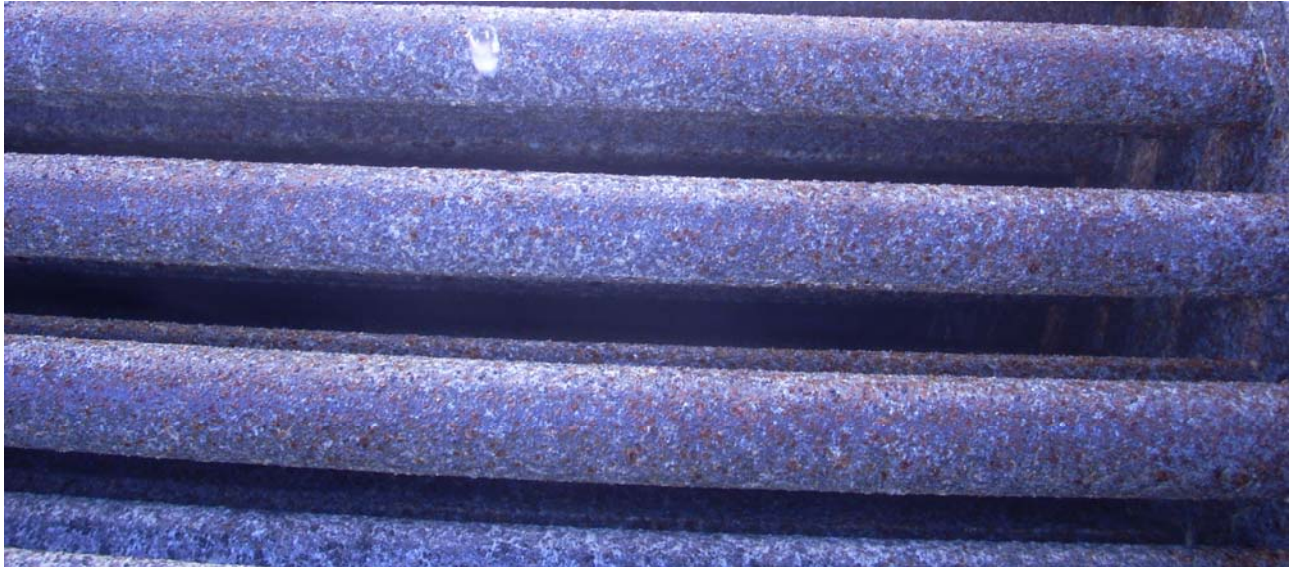
Our inspection of the cooling tower found that the tube bundle was severely corroded, white rust (zinc) and red rust (iron) corrosion products are present as shown in the following photograph. A hard, gray scale was also present between the corrosion deposits.

Chemical analysis results from the cold well deposit are surprising in that while the expected substantial amount of calcium was present, zinc was present in an almost equal amount. The deposit found in the cold well is composed almost entirely of calcium compounds from precipitation of calcium found in the cooling tower makeup water and **zinc compounds from corrosion of the galvanized tube bundle**. The loss of zinc from the tube bundle due to white rust corrosion, combined with the high level of chloride and sulfate present, and intermittent operation of the cooling towers can explain why red rust is already evident on a tube bundle that is just two years old, in spite of the water being very scaling. It is expected that the tube bundles in these cooling towers will have to be replaced in the near future due to corrosion pin holing.

Intermittent operation and white rust corrosion, it is impossible to get a protective scale to form over white rust, has prevented formation of a hard, adherent corrosion controlling scale on the tube bundles. This effect, combined with very high levels of corrosive anions and loss of the zinc galvanize surface, results in rapid corrosion of the tube bundle and the appearance of the red rust corrosion products observed on the tube bundles. The obvious conclusion is that the NCD is ineffective for control of either white rust or ferrous metal corrosion.

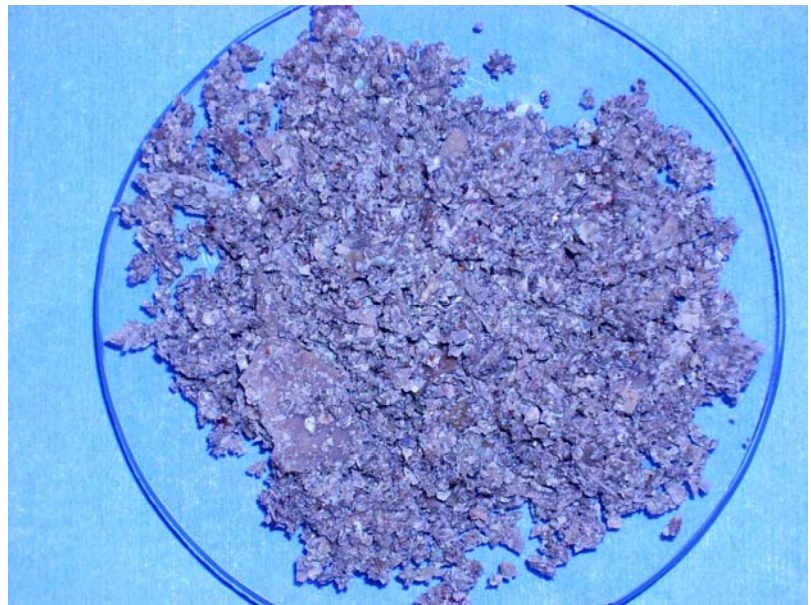
The cooling tower basins were then examined and a substantial amount, several inches, of deposit was noted on the bottom. On removal, the deposit appeared to be flakes of scale, a greenish color was noted, and the material had an obvious bad odor. This material is shown in the photograph at right on a laboratory watch glass prior to analysis

Parameter	Results as % dry weight
loss on ignition	33.1
aluminum as Al ₂ O ₃	0.15
calcium as CaO	25.9
copper as CuO	0.52
iron as Fe ₂ O ₃	0.73
magnesium as MgO	0.99
silicon as SiO ₂	2.8
phosphate as PO ₄	<0.01
sulfate as SO ₄	0.95
zinc as ZnO	23.7
ATP, 1.3 gram/100 ml water, RLU	14,973

A large amount of scale was present in the cooling tower basins, with little noted on the fill and tube bundles. It is believed that this observation is due to intermittent operation of the cooling tower resulting from the low building occupancy (low thermal load). The tube bundles and fill dry out between cooling tower operation periods and any scale that has formed flakes off the tube and fill surfaces as it dries and loses water. This explains the finding of a lot of scale flakes in the cold well basin deposit with only small amounts of hard scale observed on the tube bundles and within the fill.

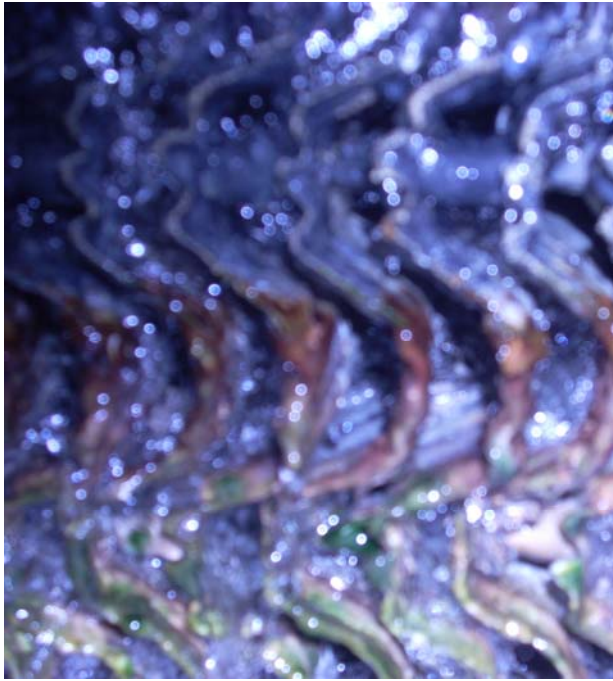
Inspection of the fill at the water line revealed substantial algae - biological growth as shown in the photograph to the left. We also noted the presence of what appeared to be a thin scale within the fill when the sheets were spit open. Unfortunately, it was not possible to obtain a good photograph of this deposit.

While the planktonic ATP results were acceptable, sessile organism levels in the cold well deposit, as indicated by the high ATP results, were excessive. We are of the opinion that planktonic organisms are removed from the cooling water during calcium carbonate precipitation, thus they are present in the cold well basin deposit. This does present a problem in that the deposit provides a base for microbiologically induced corrosion as well as under deposit corrosion. Considering this information, there is no evidence that the NCD is providing any form of biological control.
